RE: Second Quarter 2001 Inspections

On June 7, 2001, PSOMAS completed the Second Quarter Inspection of SCA's Impoundments, Refuse Pile, and Excess Spoil Disposal Areas. These areas appeared stable, with no structural weakness or hazardous conditions.

IMPOUNDMENT INSPECTION AND CERTIFIED REPORT		Clear Water Pond	
Permit Number	ACT/007/035	Report Date 7/10/01	
Mine Name	SUNNYSIDE REFUSE AND SLURRY		
Company Name	SUNNYSIDE COGENERATION ASSOCIATES		
Impoundment Identification	Impoundment Name	Clear Water Pond	
	Impoundment Number	004	
	UPDES Permit Number	UT 024759	
	MSHA ID Number	N/A	
IMPOUNDMENT INSPECTION			
Inspection Date	6/7/01		
Inspected By	Scott Carlson		
Reason for Inspection (Annual, Quarterly or Other Periodic Inspection, Critical Installation, or Completion of Construction)		Second Quarter Inspection 2001	
<p>1. Describe any appearance of any instability, structural weakness, or any other hazardous condition.</p> <p>NONE</p>			
Required for an impoundment which functions as a SEDIMENTATION POND.	<p>2. Sediment storage capacity, including elevation of 60% and 100% sediment storage volumes, and, estimated average elevation of existing sediment.</p> <p>Storage Capacity = 4

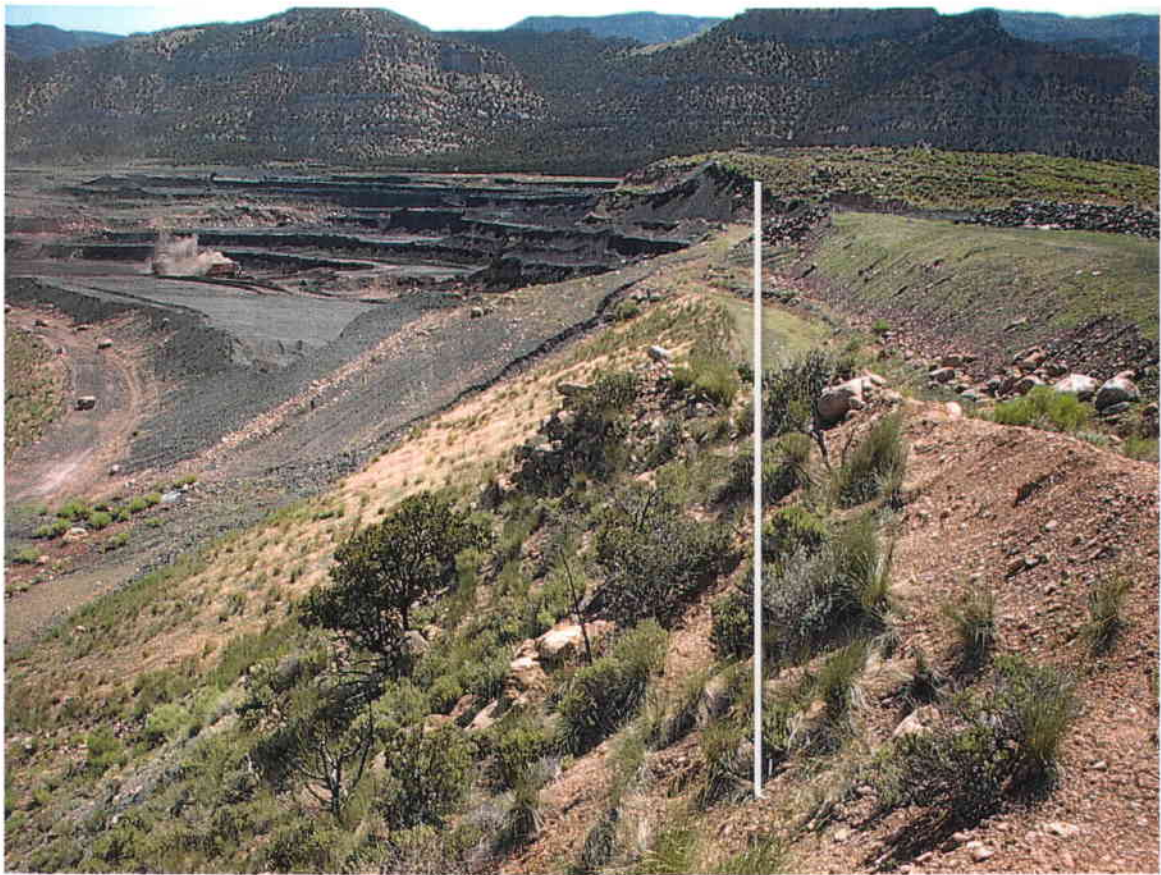
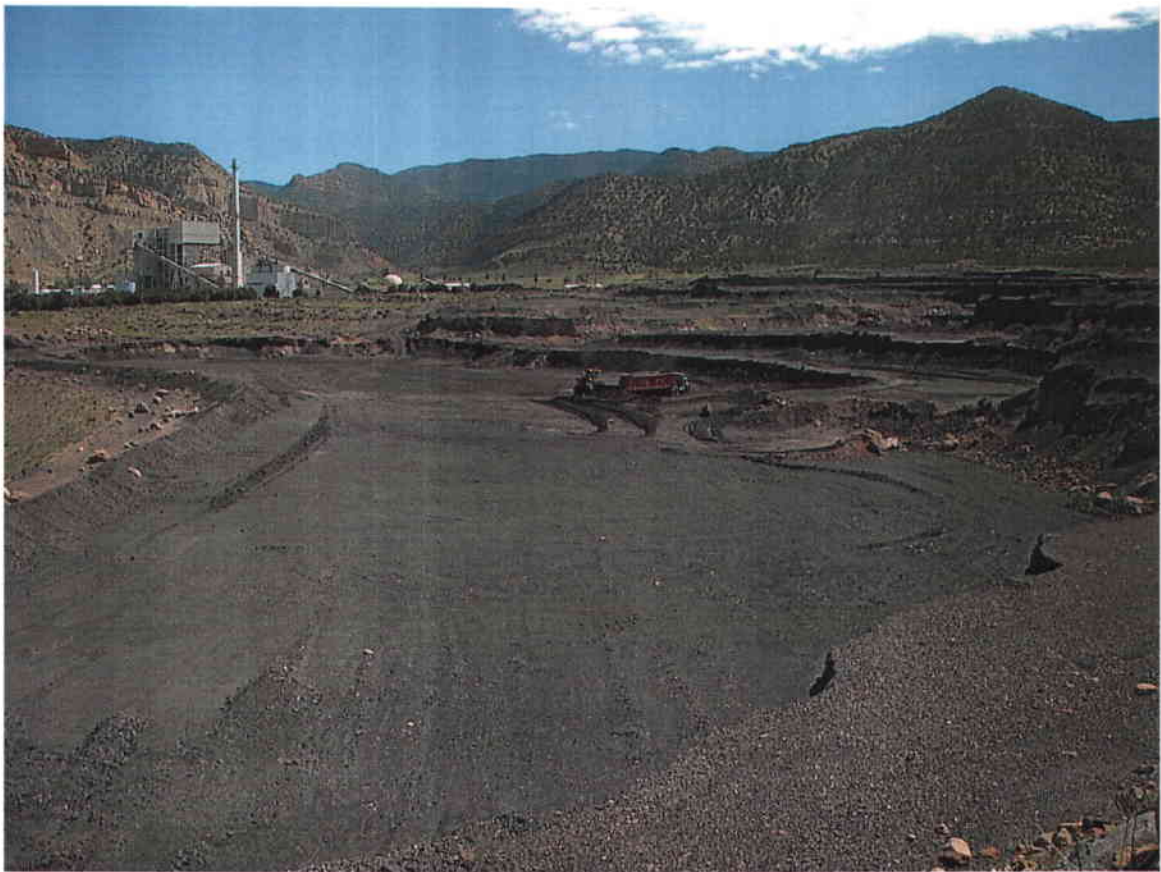
Coarse Refuse Pile

Waste Coal Removal

No smokers visible

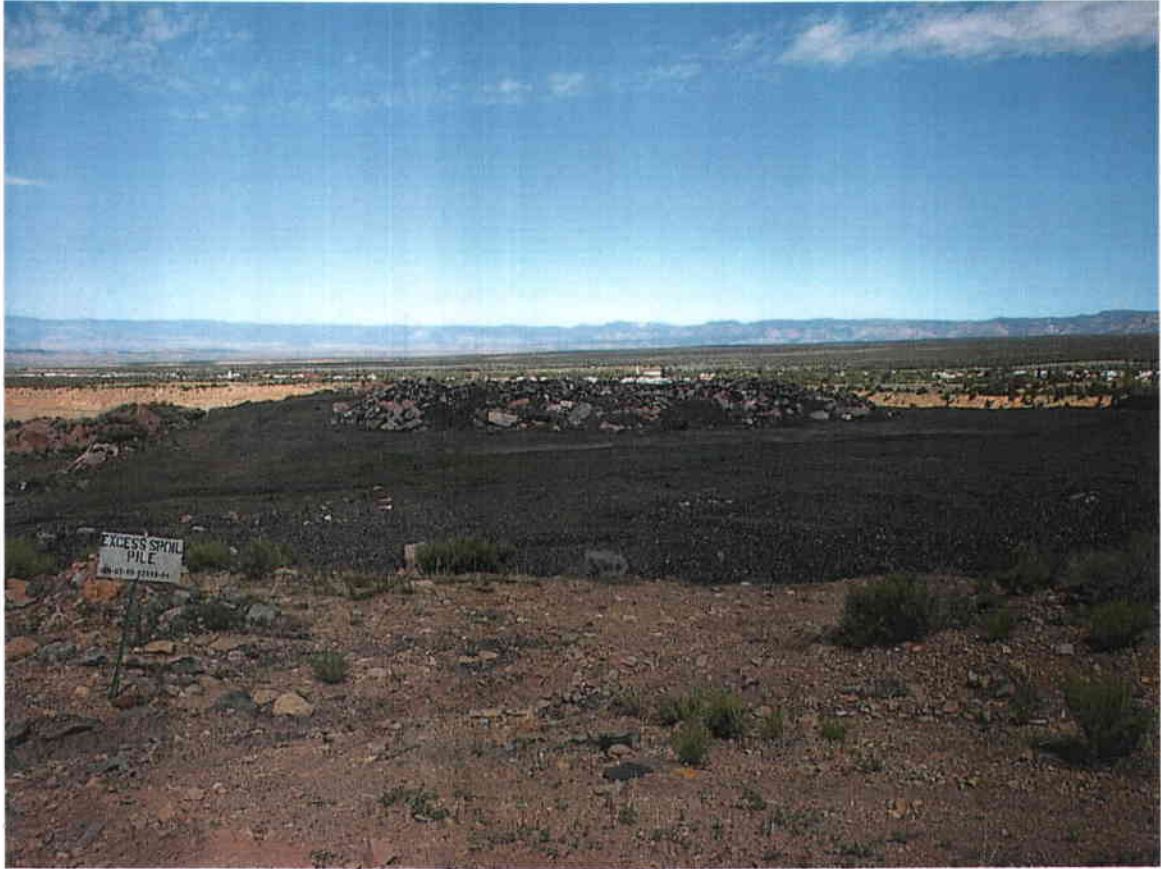
Excess Spoil Disposal Area # 1

3. Installation of final surface drainage systems. N/A			
4. Placement and compaction of fill materials. Did not receive spoils material during this Quarter.

INSPECTION AND CERTIFIED REPORT ON EXCESS SPOIL PILE OR REFUSE PILE	Excess Spoil Pile #1	
<p>5. Final grading and revegetation of fill.</p> <p>N/A</p>		
<p>6. Appearances of instability, structural weakness, and other hazardous conditions.</p> <p>None</p>		
<p>7. Other Comments. Describe any changes in the geometry of the Excess Spoil/Refuse Pile structure, instrumentation, average and maximum lifts of materials placed in the pile, elevations of active benches, total and remaining storage capacity of the structure, evidence of fires in the pile and abatement of such fires, volumes of materials placed in the structure during the year, and any other aspect of the structure affecting its stability or function which has occurred during the reporting period.</p> <p>No Construction occurred during this quarter. Construction in previous quarters had been proceeding in shallow lifts in general conformance with the approved plan.</p> <p>No evidence exists of fires in the pile.</p>

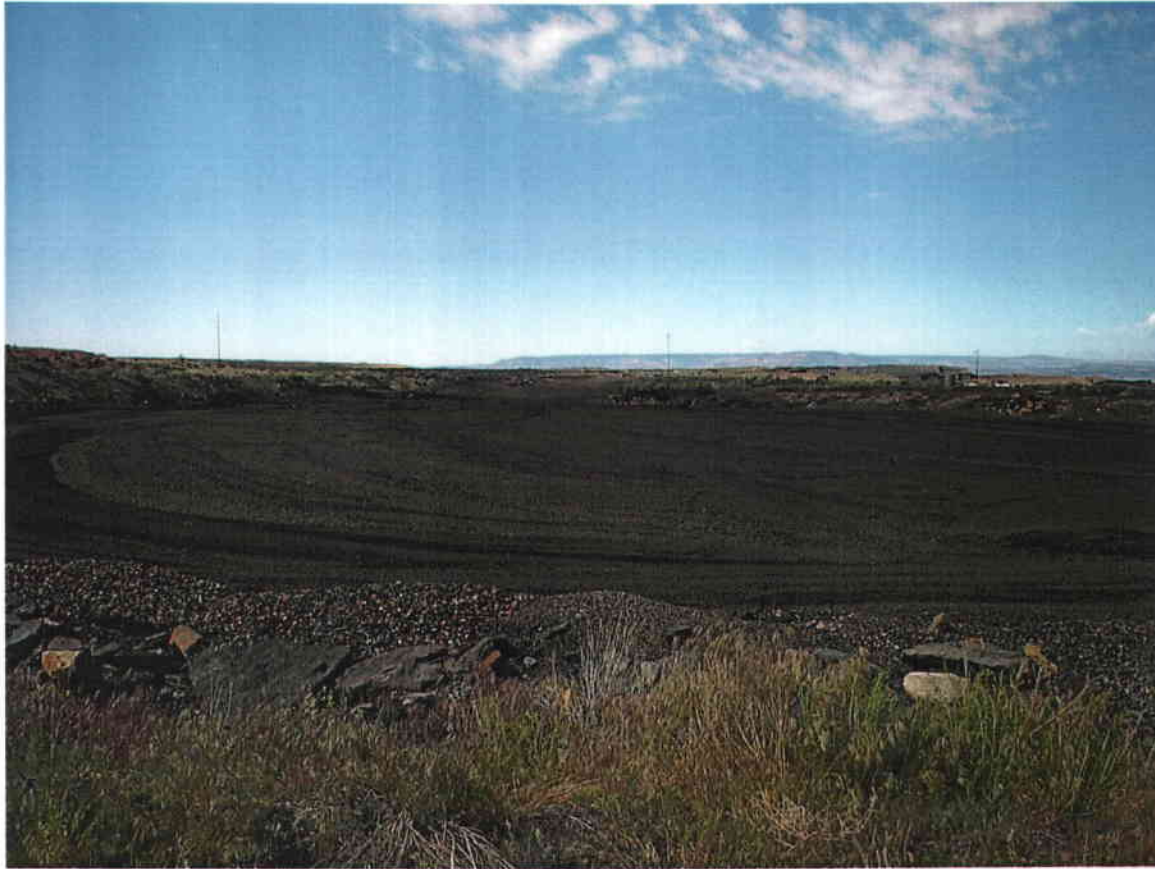
Excess Spoil Disposal Area # 2

3. Installation of final surface drainage systems. N/A			
4. Placement and compaction of fill materials. Placement and compaction of fill material continues in this disposal area. Material consists generally of coarse refuse rejects and is being placed in general conformance with the approved plan. Approximately 4,667 tons of material was placed during the Quarter.

INSPECTION AND CERTIFIED REPORT ON EXCESS SPOIL PILE OR REFUSE PILE	Excess Spoil Pile #2	
<p>5. Final grading and revegetation of fill.</p> <p>N/A</p>		
<p>6. Appearances of instability, structural weakness, and other hazardous conditions.</p> <p>None</p>		
<p>7. Other Comments. Describe any changes in the geometry of the Excess Spoil/Refuse Pile structure, instrumentation, average and maximum lifts of materials placed in the pile, elevations of active benches, total and remaining storage capacity of the structure, evidence of fires in the pile and abatement of such fires, volumes of materials placed in the structure during the year, and any other aspect of the structure affecting its stability or function which has occurred during the reporting period.</p> <p>Both Slurry Pond #1 and Slurry Pond #2 have been approved to be and are being filled with coal mine waste and excess spoil in connection with construction of the Excess Spoil Disposal Area # 2.</p> <p>The Clearwater Pond is also part of this disposal area but will continue to function as a sediment pond until such time as it is needed as a disposal site.</p>
